HISTORICAL COMMISSION'S RECOMMENDATION

Re: Toll Brothers – 100 Greenridge Road Conditional Use Application

Re: Irwin/Rice Parcel, 100 Greenridge Road, Upper Uwchlan Township

Irwin/Rice Parcel

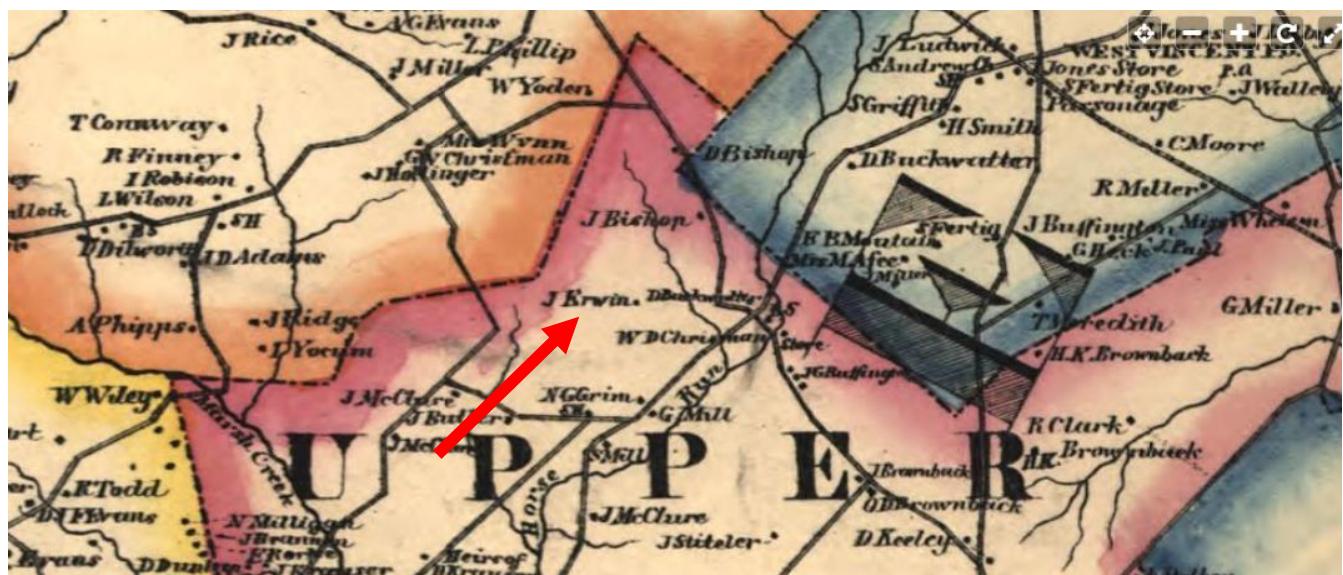
Figure 1. 1860 T.J. Kennedy, *Map of Chester County, Pennsylvania*, with “J. Erwin” indicated.

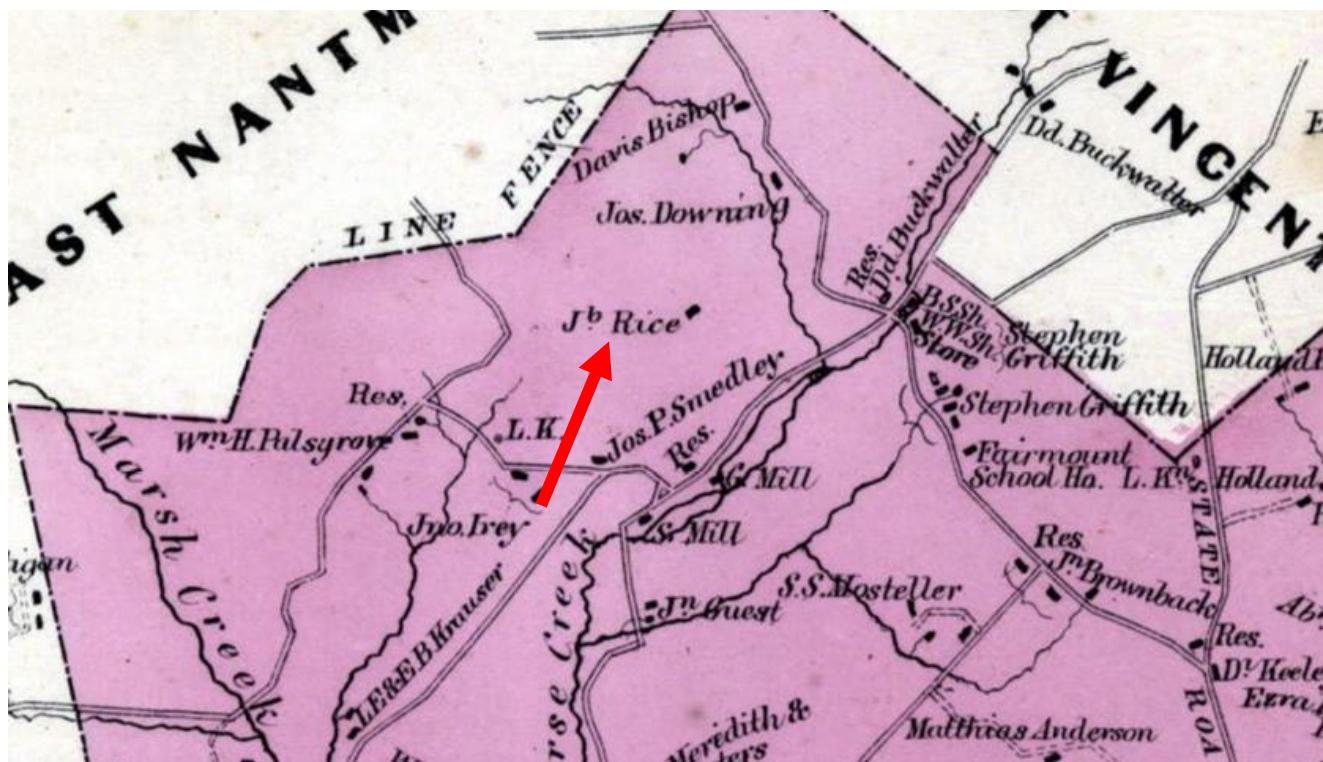
Figure 2: 1873 A.R. Witmer, *Atlas of Chester Co., Pennsylvania*. "Jb. Rice" indicates Jacob J. Rice, the owner / occupant.

The next owner of the Irwin/Rice parcel was the Rice family. Jacob J. Rice (1801-circa 1885) owned the house and parcel for 14 years, having purchased it from Osborn in 1869 (CCD 1869: S7-165-302). Rice’s name appears on the 1873 A.R. Witmer, *Atlas of Chester Co., Pennsylvania* (Figure 2) and the 1883 Forsey Breou, *Breou’s Official Series of Farm Maps, Chester County, Pennsylvania* (Figure 3). It is possible that Rice had the parcel surveyed during his ownership, as all prior deeds describe it as three acres and 90 perches (3.56 acres) while all deeds beginning with the 1869 sale describe it as three acres and 97 perches (3.61 acres). The metes and bounds of the property remained the same until it was absorbed back into the Benjamin McClure farm.

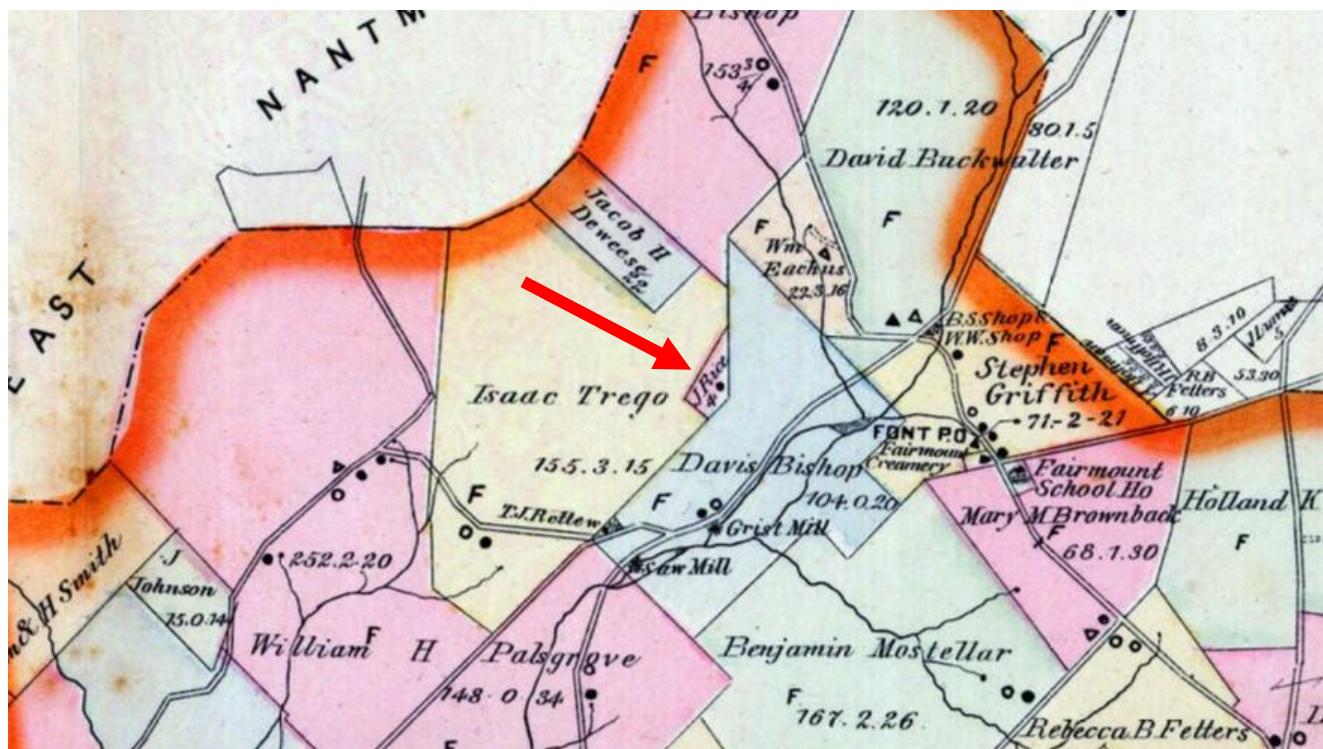
Figure 3: 1883 Forsey Breou, *Breou's Official Series of Farm Maps, Chester County, Pennsylvania*. The parcel is identified as "J. Rice." The solid dot indicates a stone house.

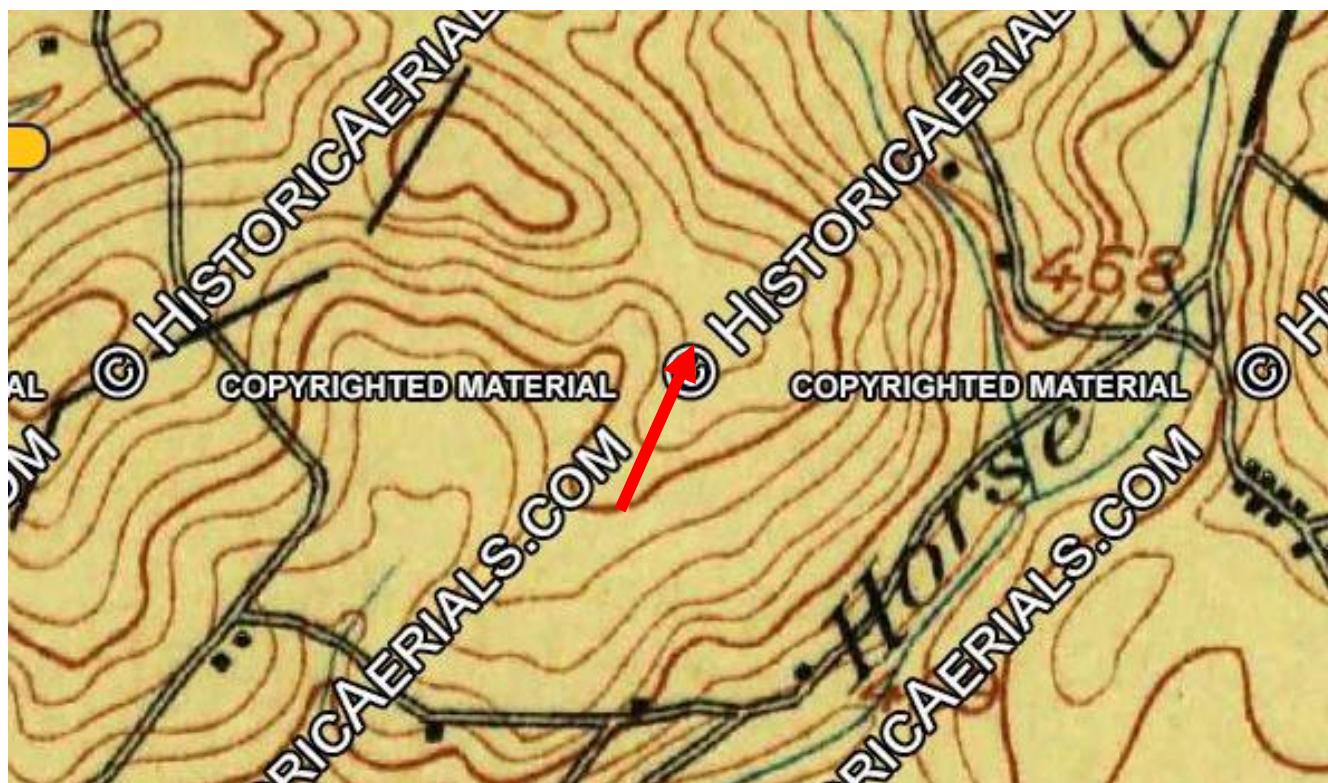
Figure 4: Detail of the 1906 U.S.G.S. quad map (Downingtown quadrangle). The arrow indicates the approximate location of the Irwin/Rice parcel.

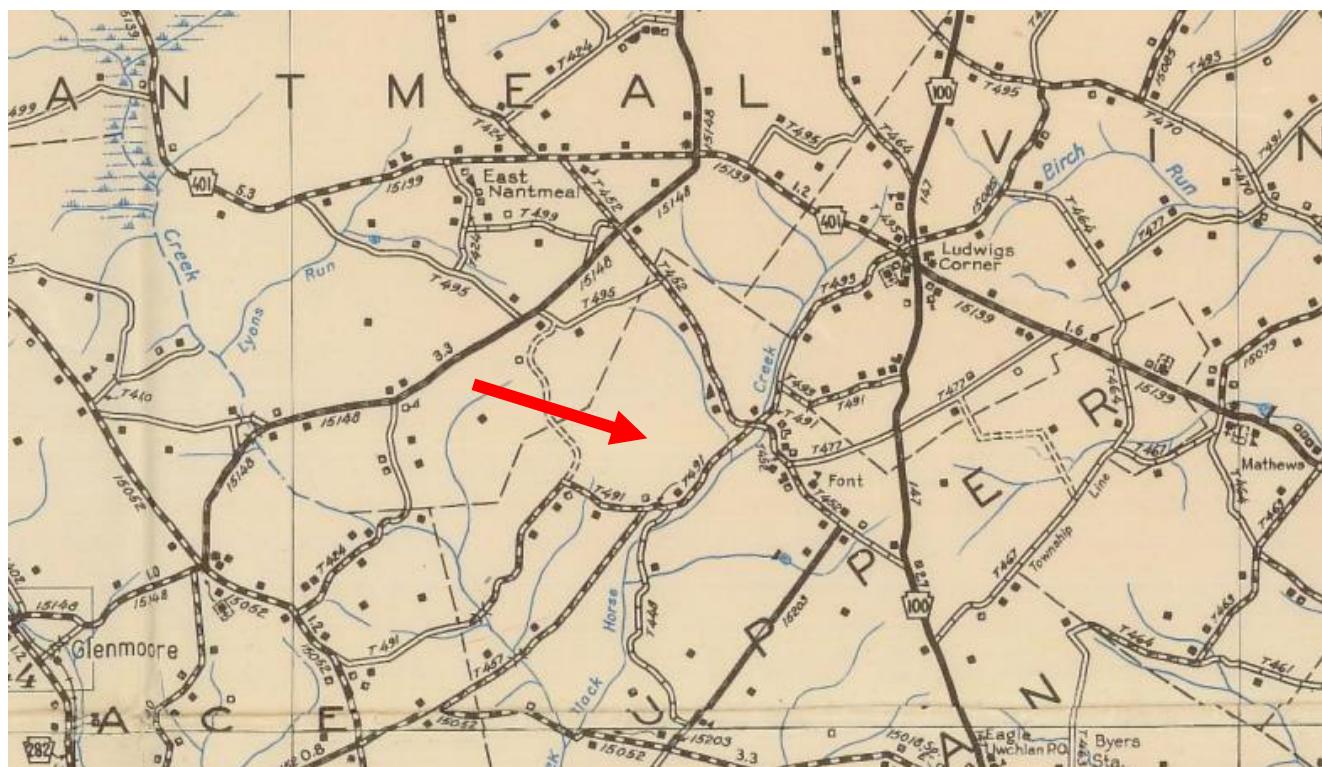
Figure 5: Detail of the 1941 *Official Highway Map, Chester County, Pennsylvania*. The arrow indicates the approximate location of the Irwin/Rice parcel.

It is unclear how long the house stood on the property; research for this project did not identify evidence that the house survived past the end of the nineteenth century. Deeds suggest that the house was in poor condition even in the nineteenth century. The highest property value was in 1869, when Jacob J. Rice paid \$545 for the house and land (CCD 1869: S7-165-302). The parcel's value then fell to \$350 in 1883 and to \$250 in 1887 (see Table 1. Chain of Title). Perhaps the house was vacant throughout the 1880s, as Jacob Rice was living in West Vincent in 1880. No twentieth-century map indicates the subject dwelling. The initial U.S.G.S. topographic quadrangle for the area was published in 1906 and it and the 18 subsequent quadrangle maps do not show the house (Figure 4). A detailed road map of Chester County, completed in 1941, shows buildings along Chester County roads and does not indicate a house in this subject parcel's location (Figure 5).

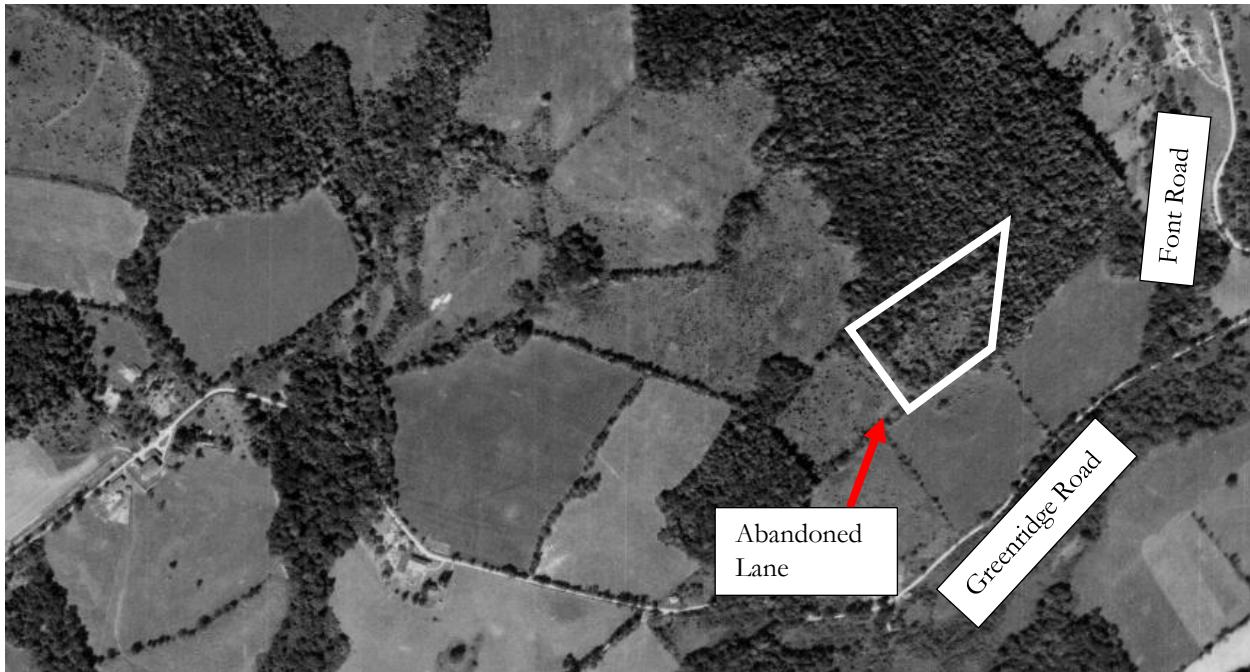
This report also examined the stone walls on the former Benjamin McClure Farm, also located at 100 Greenridge Road. The former Benjamin McClure Farm contains a stone wall just west of the circa 1985 stone mansion house. The Upper Uwchlan Township Historical Commission requested that RGA examine this wall for historic significance. The wall appears to be one of several that are visible on the 1937 aerial photograph (Figure 6).

Figure 6: Historic aerial photograph dated September 20, 1937, adapted from the Pennsylvania Imagery Navigator (tile ahk_4351). The Irwin/Rice Parcel, identified by the white outline, is in the process of reforestation. Its abandoned lane leads southwest to Greenridge Road along a treeline. The larger Benjamin McClure farm property to the west and south displays farm fields divided by tree lines (possibly with stone walls).
